## IPEC Replaces Failed Screen at Beef Processing Plant

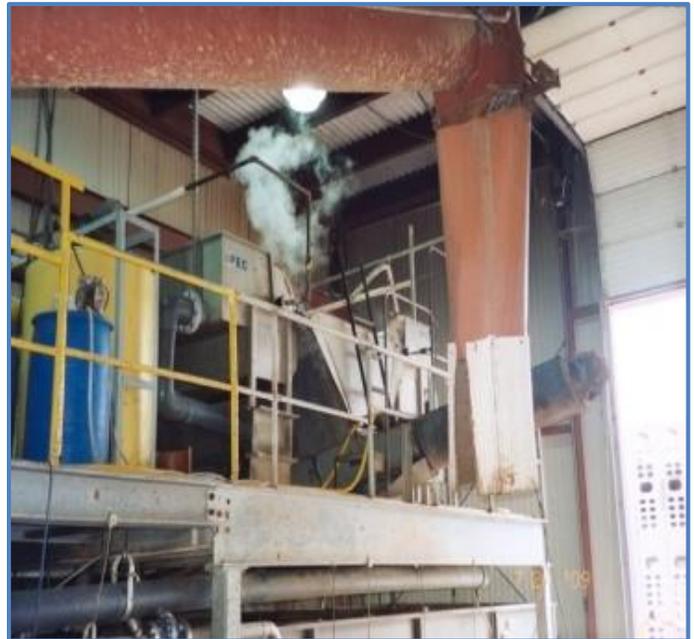
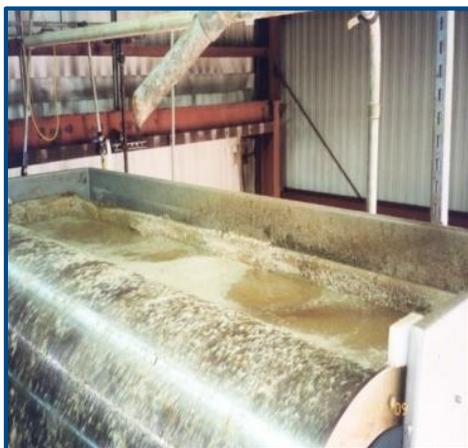
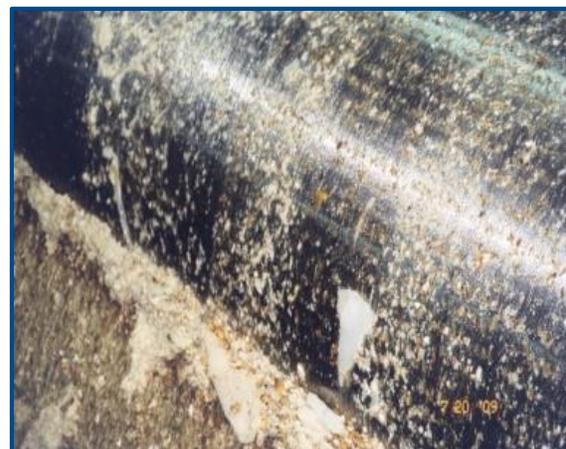
The screens remove solids generated from the processing area including miscellaneous trash from floor washdown and also the manure solids from the holding area. The screens protect the DAF units from large solids and heavy loading and allow the DAF units to produce an effluent that is then discharged to the POTW.

**Solution:** The plant engineer searched for an externally fed screen that offered both a rugged design along with a built-in overflow system. The IPEC RSS externally fed screen met both criteria and the plant purchased and installed two (2) model RSS2596 with 0.020" wedge wire drums. The combined flow from the processing area and the holding pen area goes to the sump where there are two (2) trash pumps each with a capacity of 300 GPM and the operation is controlled by the level in the sump. The flow to the screens is either 300 GPM or 600 GPM depending on whether one or both pumps are in use. The flow is normally split between the two screens but can be handled by one screen if the other is down for inspection or maintenance.
